Experimental Study ND 98-02

**Snow Management by the Use of
Snow Fence Systems**

First Evaluation

March 2003

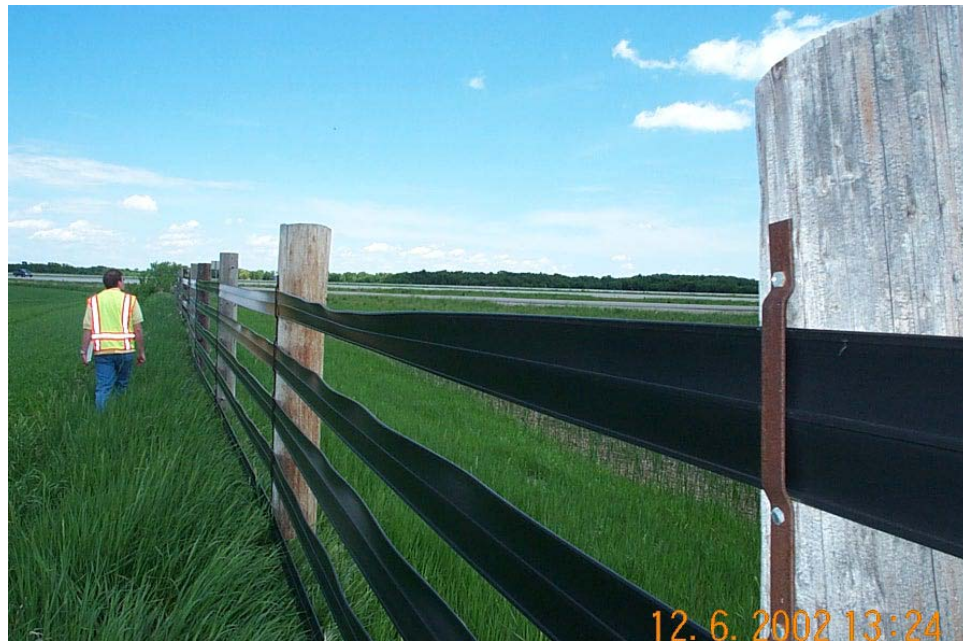
Sites 2, 3, and 4 were inspected on June 12, 2002 and site 1 was inspected on August 12, 2002. The overall condition of the snow fences was good. The ratchet hardware showed signs of corrosion but appeared to be operable. The polymer strap material showed no signs of deterioration but on most snow fences the polymer straps need to be adjusted by tensioning the straps. Photo 3 shows a fence with polymer straps that need tensioning.

Photo 3 - Loose polymer straps.

Installation of the snow fence systems went well. The structural snow fences are in good condition but do require maintenance to keep the polymer straps tensioned and to reattach the loose brackets. The living snow fence is thriving and has grown significantly.

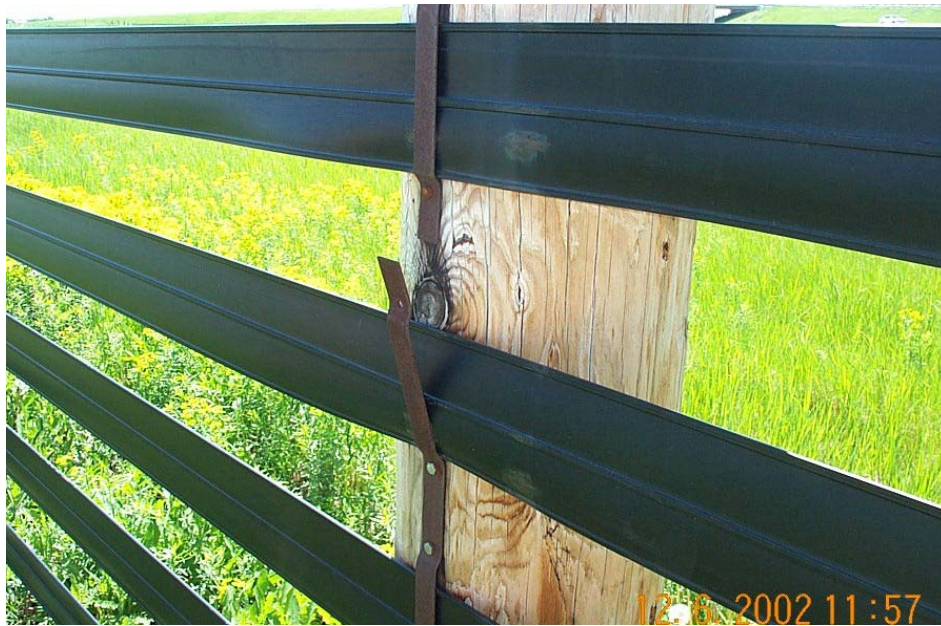
It was typical to see, that one or two brackets per fence had become loose. These brackets hold the polymer straps in position and are attached to the posts by screws. The brackets had become loose because the screws had pulled out of the posts. It appeared the screws had pulled out because the posts had cracked. The salvage posts had more cracks and loose brackets than the purchased posts. This problem could probably be addressed by using bigger screws. The loose brackets didn't appear to be a problem. Photo 4 shows a bracket that had become loose.

Photo 4 - Bracket that has become loose.

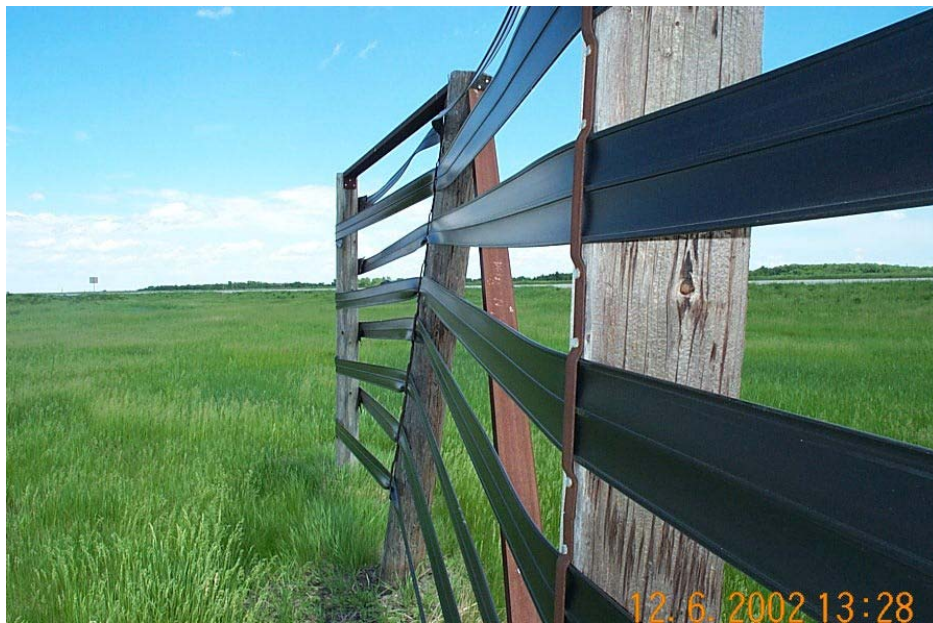
At site 4, a fence post had tilted and had caused some of the polymer straps to become loose and other straps to bind. Photo 5 shows the tilted post. This post was near the north end of an eight-foot fence that is located between Interstate 29 and the southbound exit ramp. This end of the fence is in an area that appeared to collect water and the ground at the base of the fence post was wet and quite soft.

Photo 5 - A tilted fence post at Site 4.

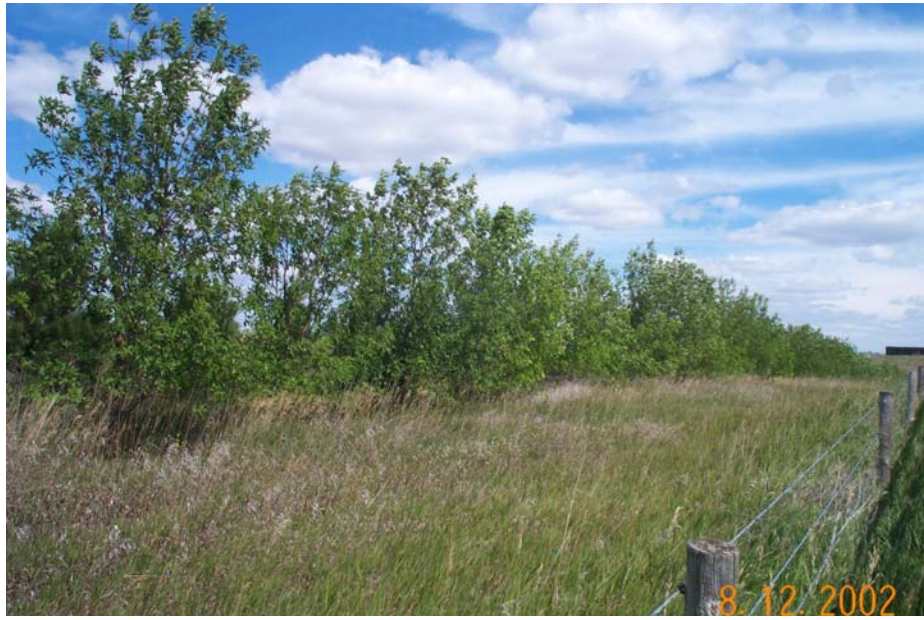
The living snow fences at site 1 appeared to be thriving and no trees appeared to have died. The Green Ash trees are approximately 12'-16' tall and the Pine trees are approximately 8'-10' tall. The condition of the living snow fence is shown in photos 6 and 7. The height of the living snow fence in 1998 is shown in photo 1.

Photo 6 - A view of the living snow fence in 2002.

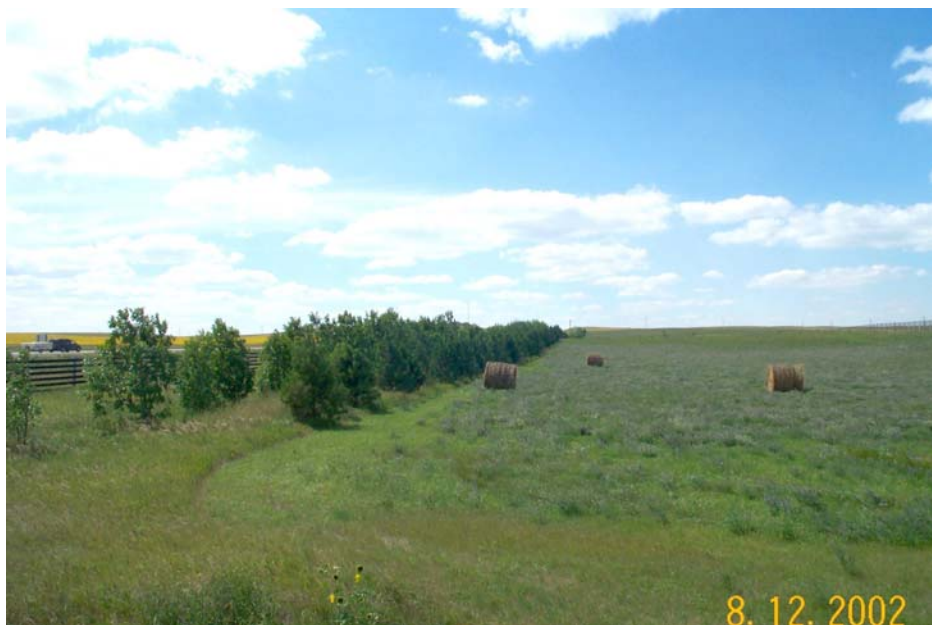
Photo 7 - Another view of the living snow fence in 2002.

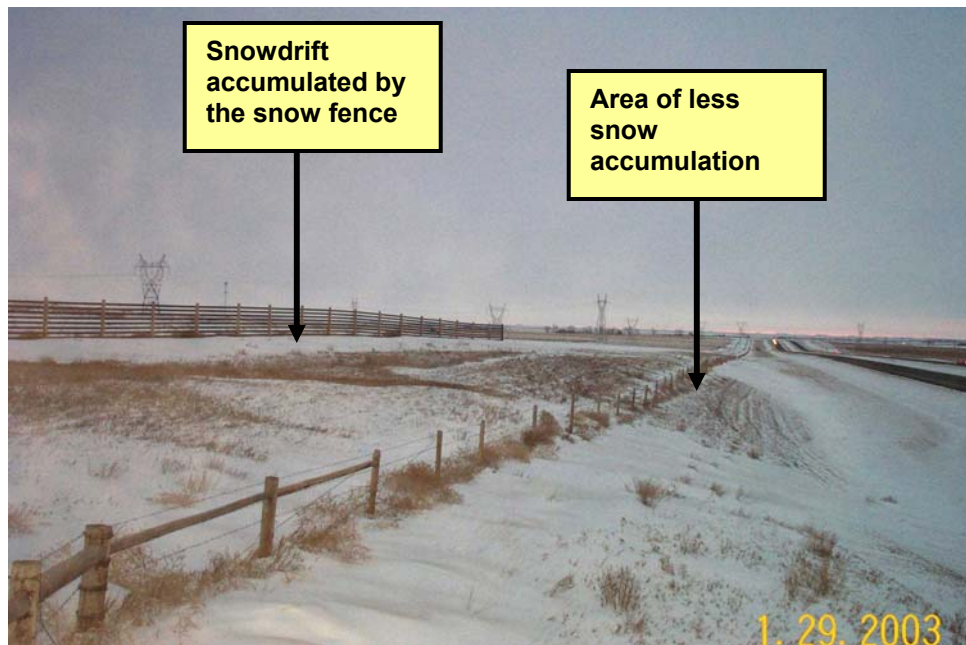
All of the snow fences had collected a drift on the downwind side of the fence and most had also collected a drift upwind of the fence. Downwind of some snow fences there was an obvious area where less snow had accumulated on the ground than in the surrounding area. Photo 8 shows a snow fence with an area of less snow accumulation at site 2.

Photo 8 - A snow fence at site 2 in January 2003.

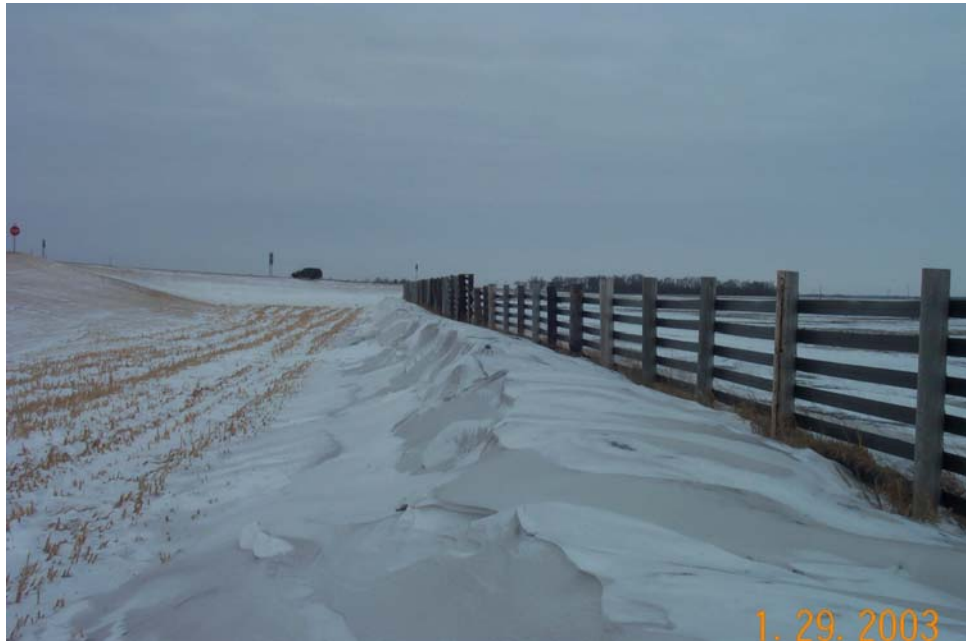
Snow fences at higher locations than surrounding areas appeared to collect more snow than fences in low areas. Photo 9 shows a large drift along a snow fence in a high location on the west side of site 3. Photo 10 shows the relatively small amount of snow collected by a snow fence in a low location at site 3.

Photo 9 - A large drift accumulated by a snow fence at a relatively high location at site 3.

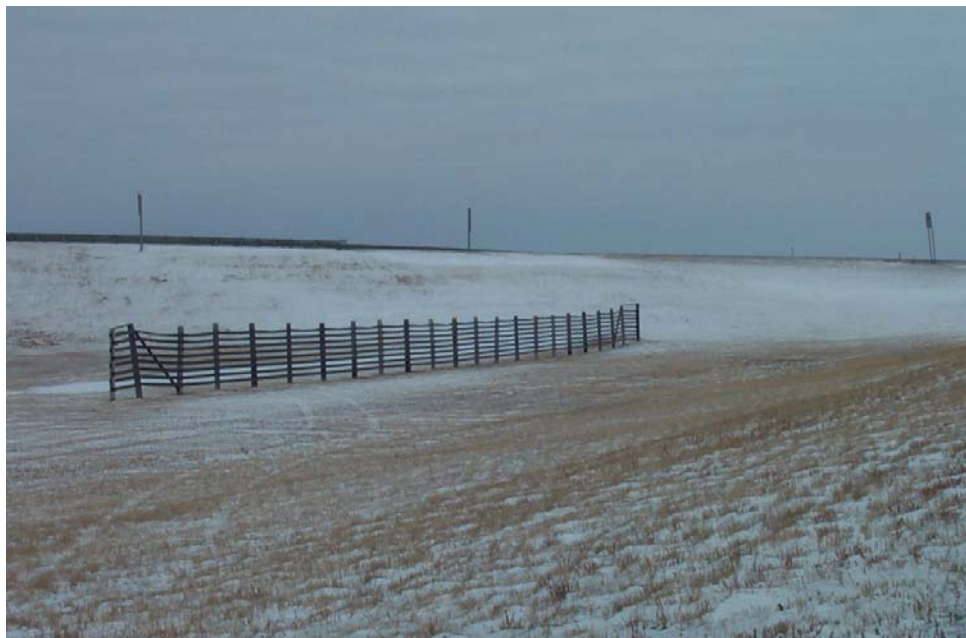
Photo 10 - A snow fence in at a low elevation at site 3 with relatively little snow accumulation.
